SUBJECT: BREZDEN INSPECTIONS

WOOD DESTROYING PESTS AND ORGANISMS INSPECTION REPORT

Building No.	Street	City	Zip	Date of Inspection	Number of Pages
150	-158 Bayshore Dr.	Morro Bay	93442	03/22/05	4

Report #: 2485

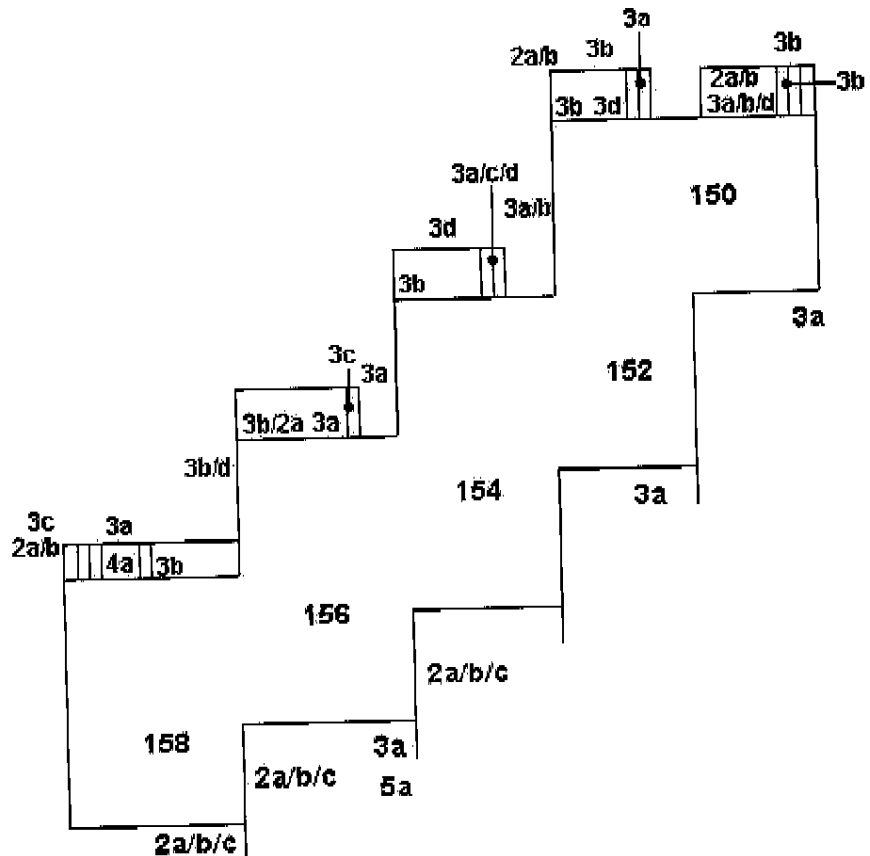
Finding: 2A Drywood Termite infestation noted to the wall framing, and front porch framing. Infestation extends into inaccessible wood members.

Finding: 2C Drywood Termite damage noted to the siding and siding trim.

Finding: 3A Fungus damage and infection noted to the siding trim.

Finding: 3B Fungus damage and infection noted to the siding.

Finding: 3C Fungus damage and infection noted to the stringers, deck boards, wall cap and pickets.

Finding: 3D Fungus damage and infection noted to the fascia, and fascia trim.

Finding: 4A Wood boring beetle infestation noted to the deck joist.

Finding: 5A The base of the trim is inaccessible due to the trim being embedded in the asphalt.
 Recommendation: Cut the trim above the asphalt and remove the embedded trim for further inspection. A written Supplemental Report outlining our findings and recommendations will be made at this time

Recommendation: Vacate the premises for a minimum of 3 days and 2 nights. Fumigate with Vikane (Sulfuryl Fluoride). Chloropicrin will be used as a warning agent. Fumigation is guaranteed for a period of 2 years.

Recommendation: Remove and replace/resupport damaged material.

Recommendation: Remove and replace/resupport the damaged and infected portions of the wood members noted above.

Recommendation: Treat the accessible area(s) of the Wood boring beetle infestation with the termiticide Timbor (active ingredient Disodium Octaborate Tetrahydrate) and/or Cy-Kick (active ingredient Cyfluthrin). Remove or cover all accessible pellets and frass of wood-destroying pest(s) noted in this report. Local treatment is not intended to be an entire structure treatment method. If infestations of wood-destroying pests extend or exist beyond the area(s) of local treatment, they may not be exterminated. No guarantee is given with the treatment.
