SUBJECT: BREZDEN REPORT - CLUBHOUSE

WOOD DESTROYING PESTS AND ORGANISMS INSPECTION REPORT

Building No.	Street	City	Zip	Date of Inspection	Number of Pages
	Bay Shore Dr.	Morro Bay	93442	02/23/05	4

General Description: one story clubhouse, comp. shingle, slab foundation	Inspection Tag Posted: hot water closet
	Other Tags Posted:

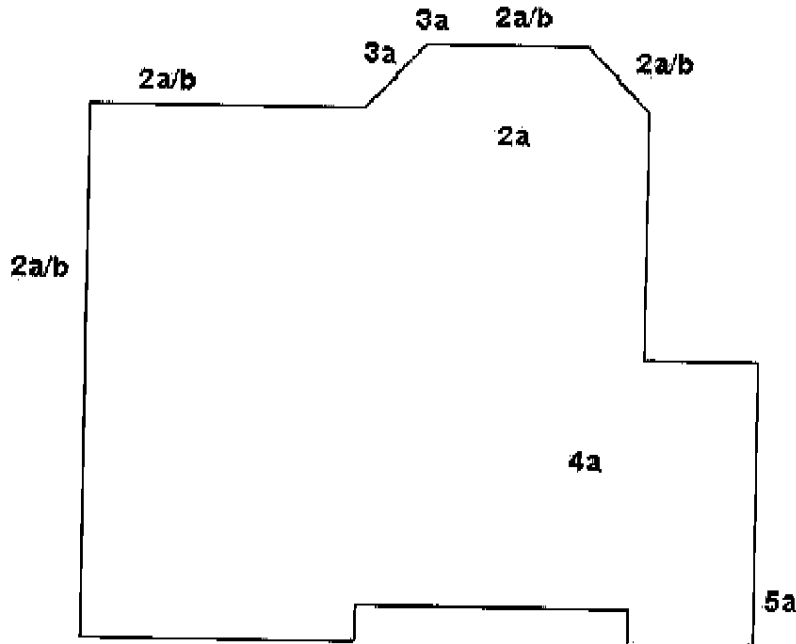
Drywood Termite infestation noted to the rafter, cross beam, window framing, window trim and siding.

Drywood Termites damage noted to the window trim and siding.

Fungus damage noted to the window trim.

Dry water stain(s) were noted on the underside of the kitchen sink.

Portion(s) of the siding was not inspected due to the siding being embedded in the concrete.

Vacate the premises for a minimum of 3 days and 2 nights. Fumigate with Vikane (Sulfuryl Fluoride). Chloropicrin will be used as a warning agent. Fumigation is guaranteed for 2 years from the date of completion. Upon completion of the fumigation, remove and/or mask the accessible pellets.

Remove and replace/resupport damaged material.

Remove and replace/resupport the damaged and infected material.

All interested parties should check with Owner for confirmation of repairs and/or source of stains. If no repairs and/or source of stains can be confirmed, we recommend Owner to contact the proper tradesman and make needed repairs.

Owner/agent to contact a qualified tradesman to inspect and make any necessary repairs to correct this finding.
