SUBJECT: BREZDEN INSPECTIONS

WOOD DESTROYING PESTS AND ORGANISMS INSPECTION REPORT

Building No. 154,	Street 158, 162 Sandpiper Ln.	City Morro Bay	Zip 93442	Date of Inspection 03/22/05	Number of Pages 4
Brezden Pest Control Inc. 3261 S Higuera Ste #100 San Luis Obispo, CA, 93401 Tel 805-544-9446 Fax 805-544-2807 Registration #: OPR6313			A LICENSED PEST CONTROL OPERATOR IS AN EXPERT IN HIS/HER FIELD. ANY QUESTIONS RELATIVE TO THIS REPORT SHOULD BE REFERRED TO HIM/HER. Report #: 2485		
Ordered by: Bayshore Village HOA 154, 158, 162 Sandpiper Ln. Morro Bay, CA 93442		Property Owner and/or Party of Interest: Bayshore Village HOA 154, 158, 162 Sandpiper Ln. Morro Bay, CA 93442		Report sent to: Bayshore Village HOA 3563 Empleo #B SAN Luis Obispo, Ca. 93401	
COMPLETE REPORT <input type="checkbox"/> LIMITED REPORT <input checked="" type="checkbox"/> SUPPLEMENTAL REPORT <input type="checkbox"/> REINSPECTION REPORT <input type="checkbox"/>					
General Description: one story single family duplex, comp. shingle, stucco and wood ext., 2 car garage, raised foundation			Inspection Tag Posted: under eaves Other Tags Posted:

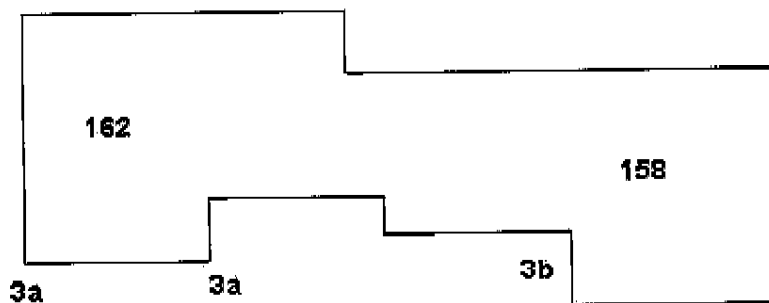
An inspection has been made of the structure(s) shown on the diagram in accordance with the Structural Pest Control Act. Detached porches, detached steps, detached decks and any other structures not on the diagram were not inspected.					
Subterranean Termites <input type="checkbox"/> Drywood Termites <input type="checkbox"/> Fungus/Dryrot <input checked="" type="checkbox"/> Other Findings <input type="checkbox"/> Further Inspection <input type="checkbox"/> If any of the above boxes are checked, it indicates that there were viable problems in accessible areas. Read the report for details on checked items.					
Key: 1 = Subterranean Termites, 2 = Drywood Termites, 3 = Fungus/Dryrot, 4 = Other Findings, 5 = Unknown Further Inspection

Limited to the exterior

Finding: 3A	Fungus damage noted to the siding trim.
Recommendation:	Remove and replace/resupport the damaged and infected portions of the wood members noted above.
Price: \$65.00	
Finding: 3B	Fungus damage and infection noted to the siding.
Recommendation:	Remove and replace/resupport the damaged and infected portions of the wood members noted above.
Price: \$125.00
